Rocky Reach Spillway Gates

Changes at Rocky Reach since 1995

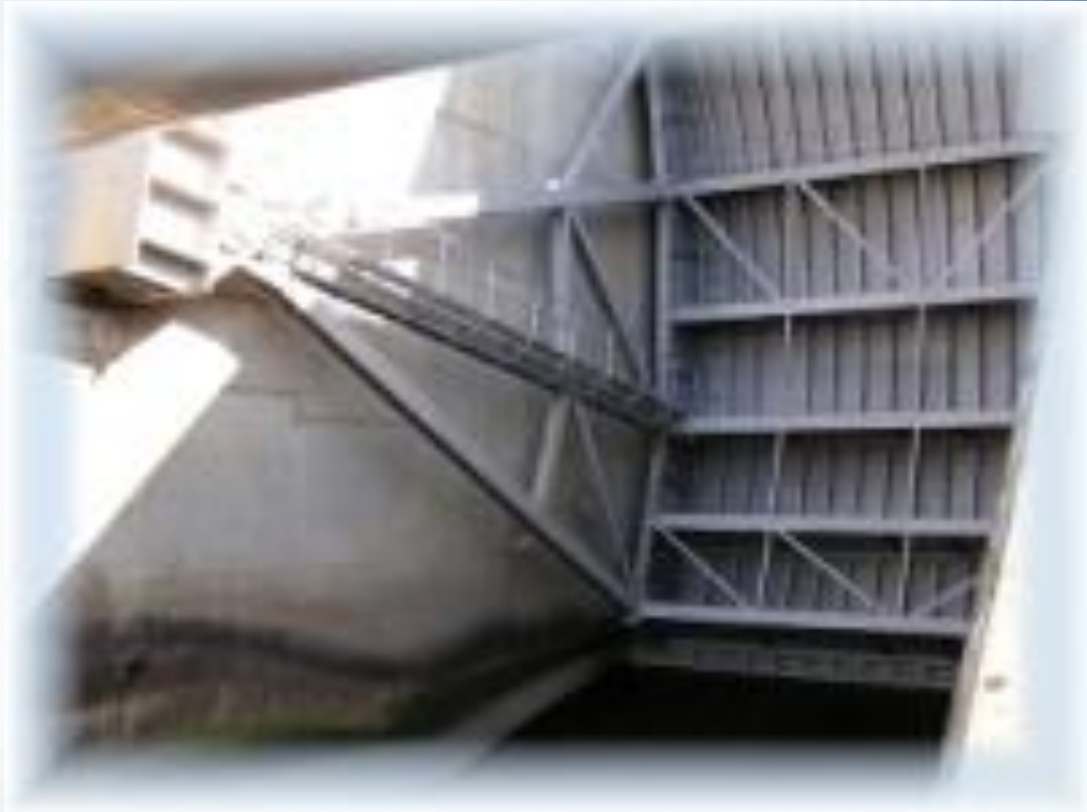
Strain gage testing program evaluated stresses from:

- Reservoir load,
- Trunnion friction, and
- Secondary effects
 - Sweep
 - Camber
 - Bearing alignment

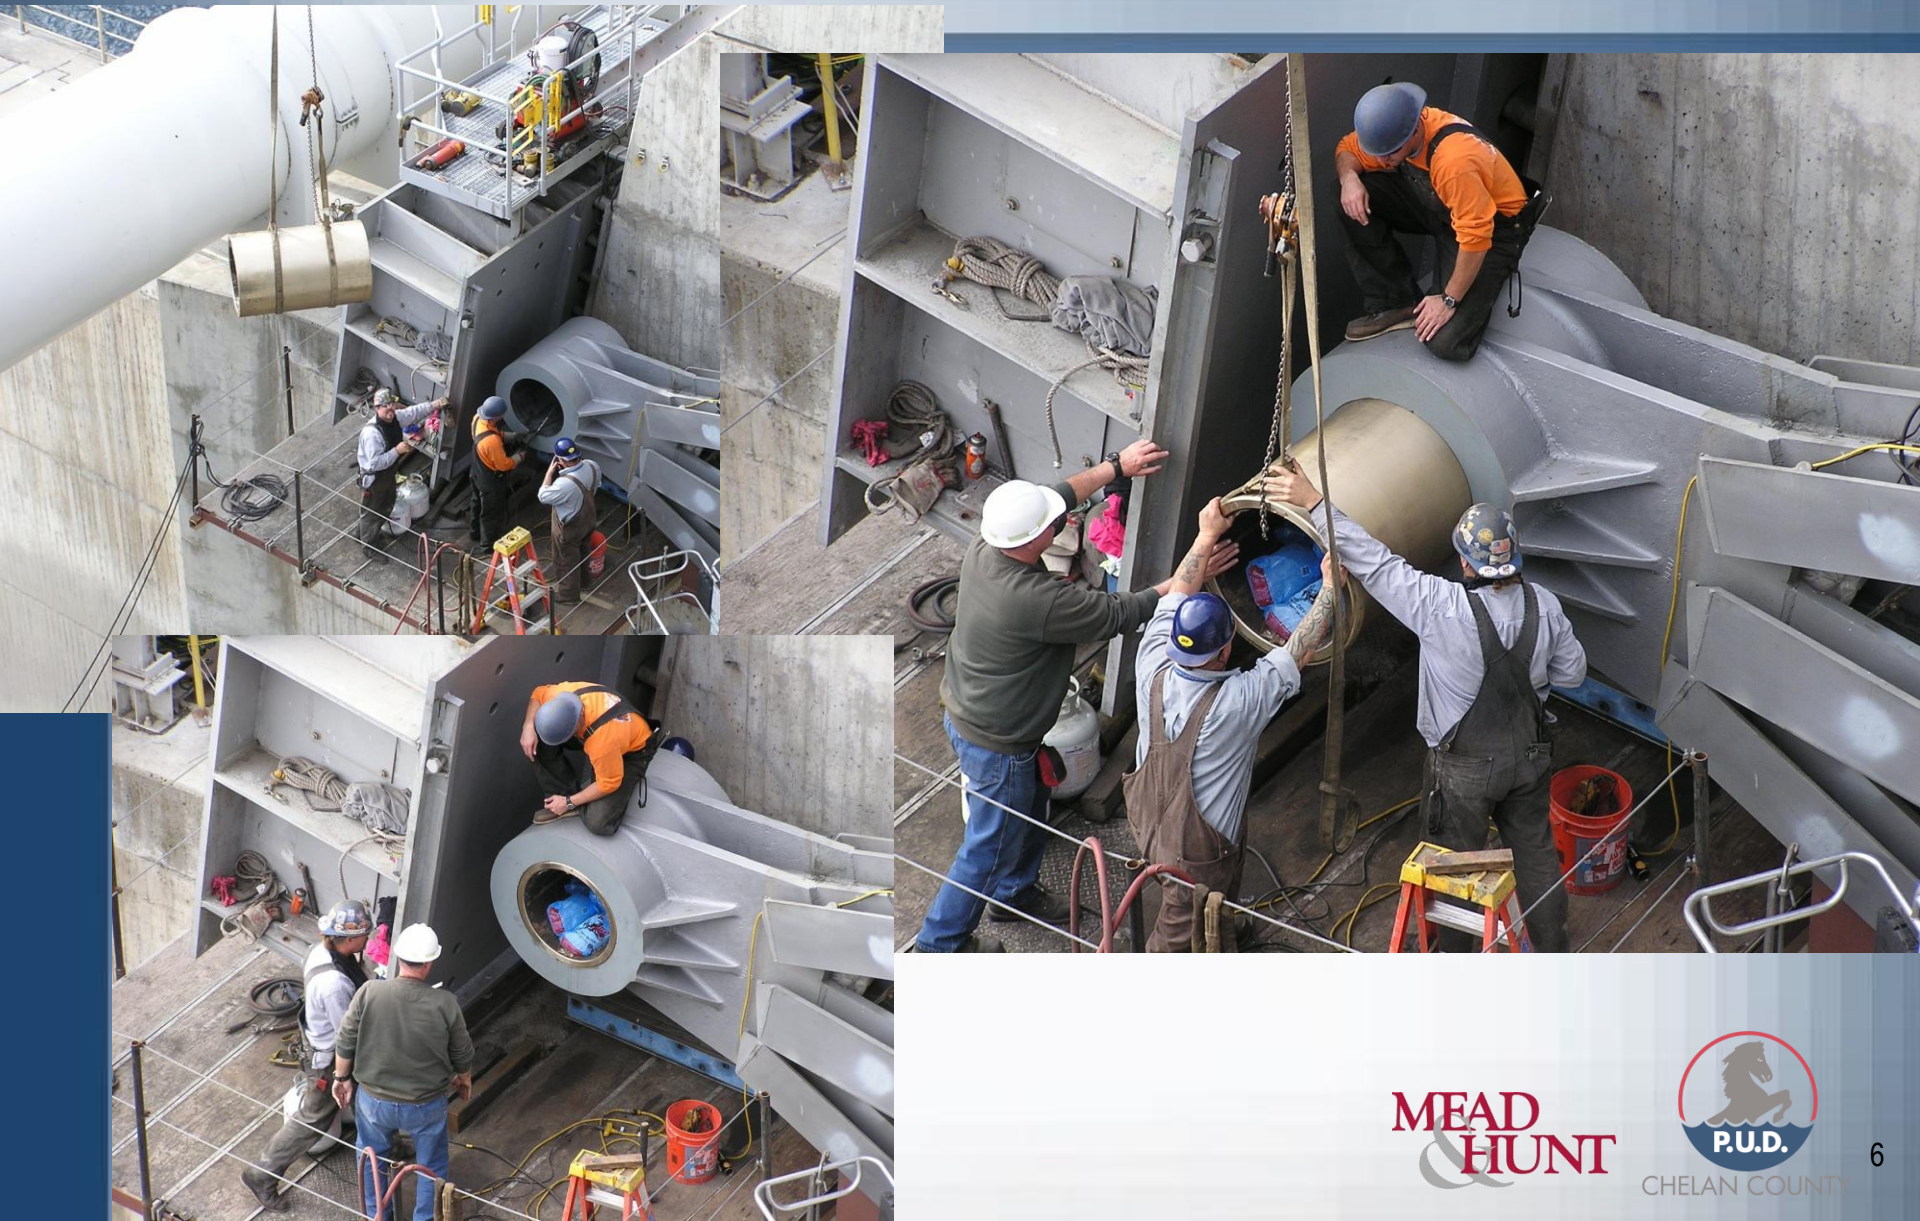
Trunnion bearing replacement

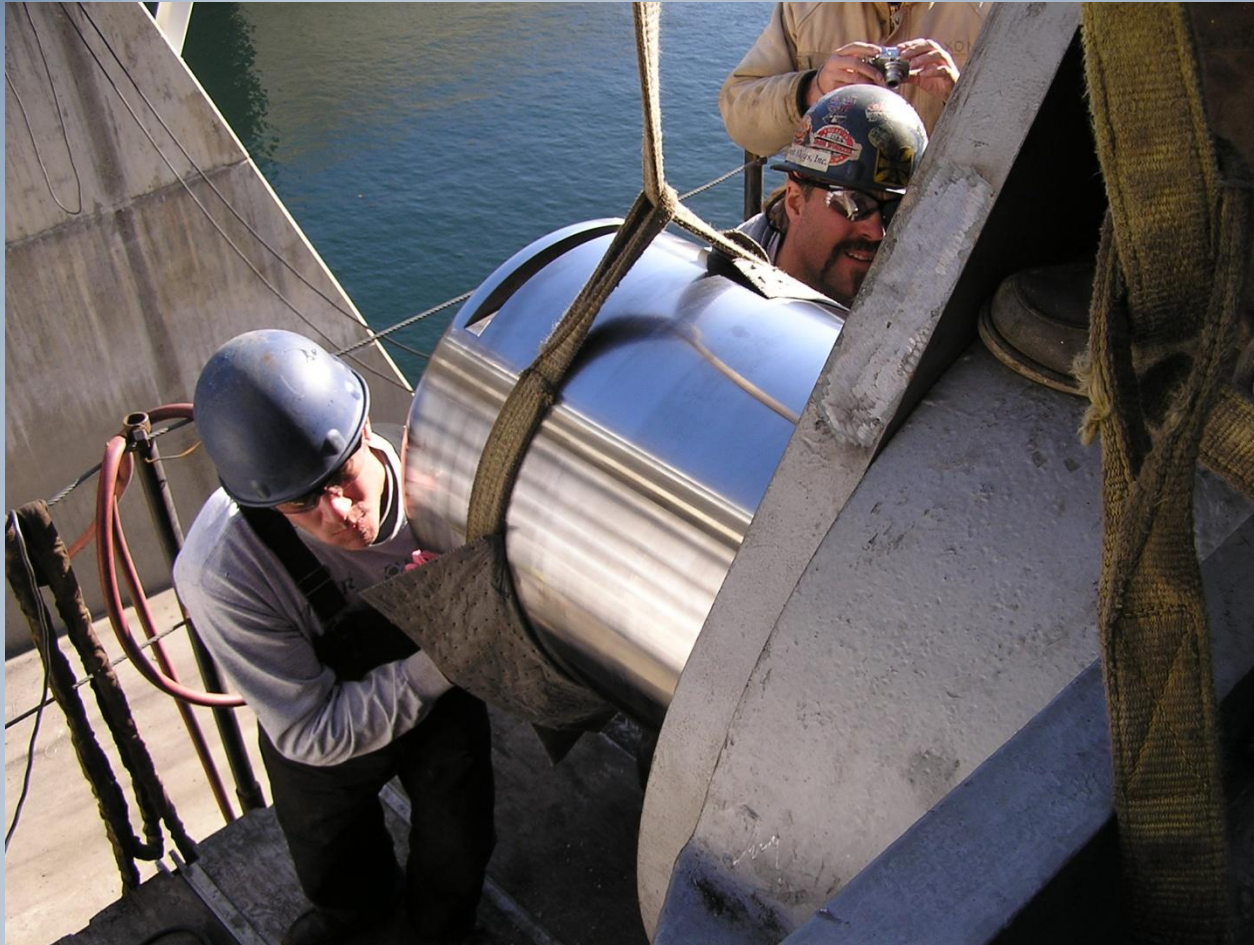
Trunnion bearing replacement

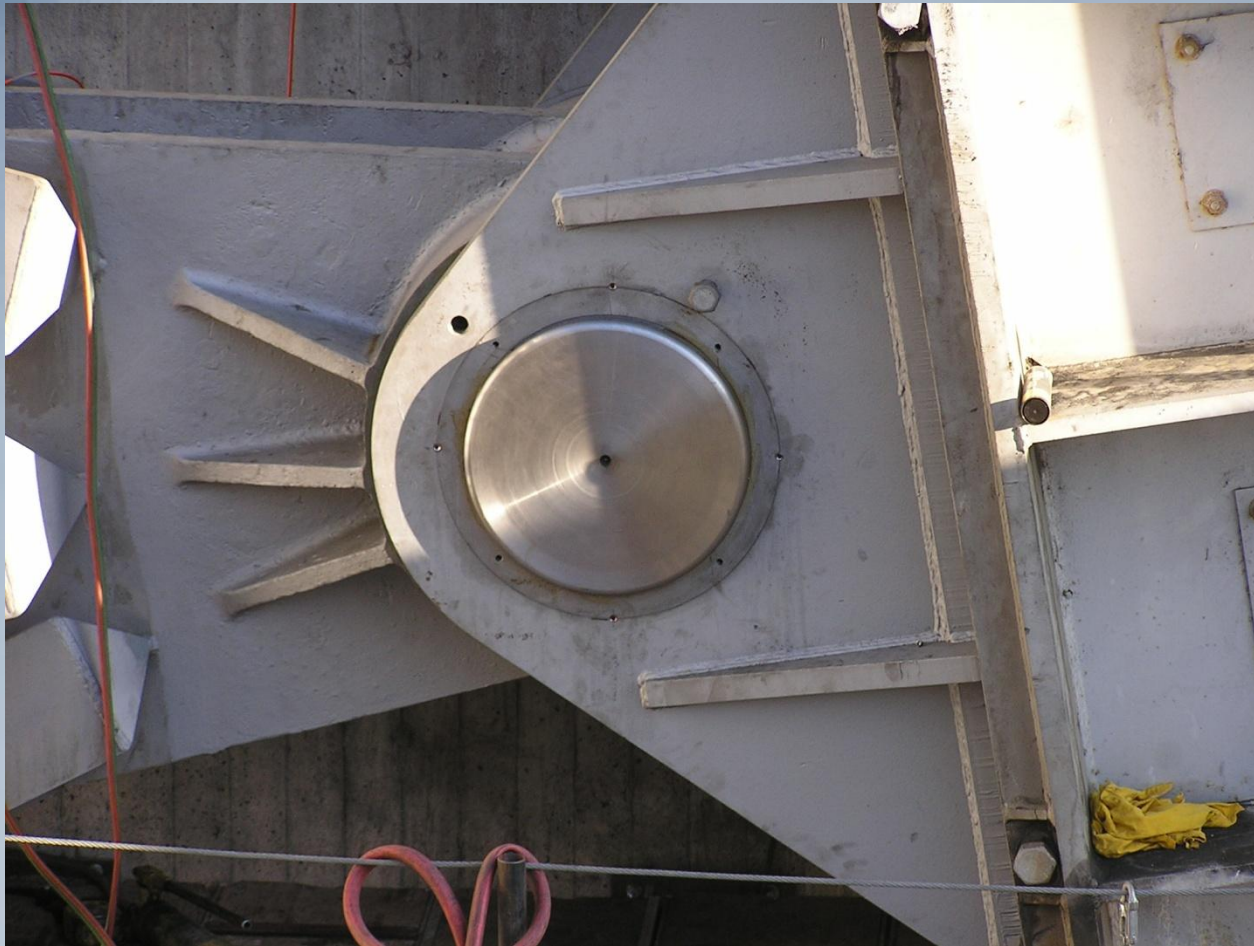
Trunnion bearing replaced

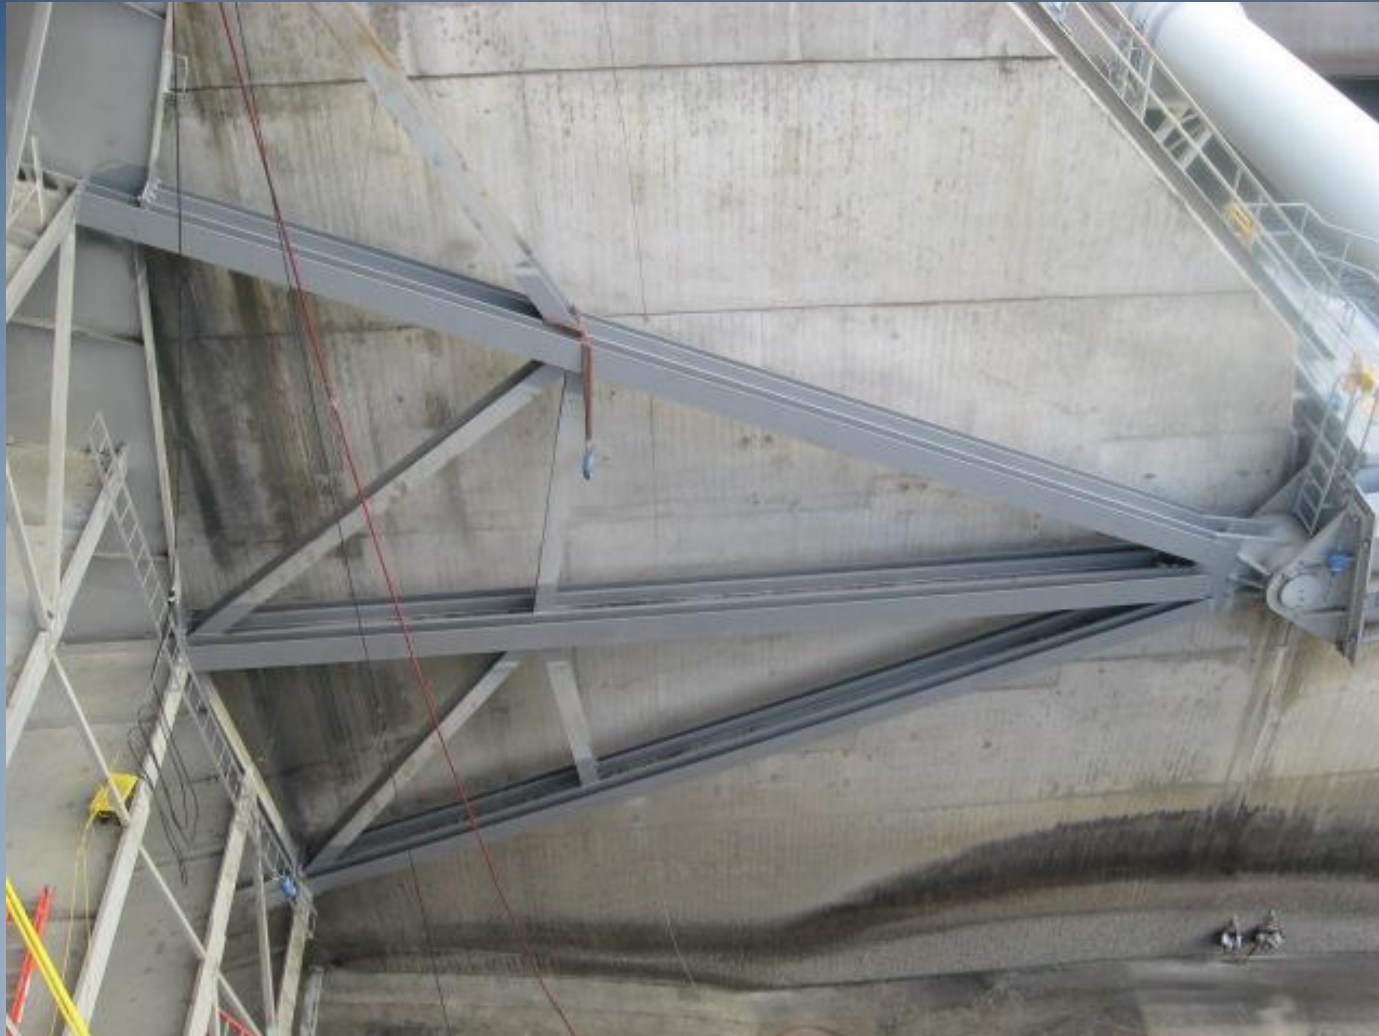
Arm strengthening – added WTs

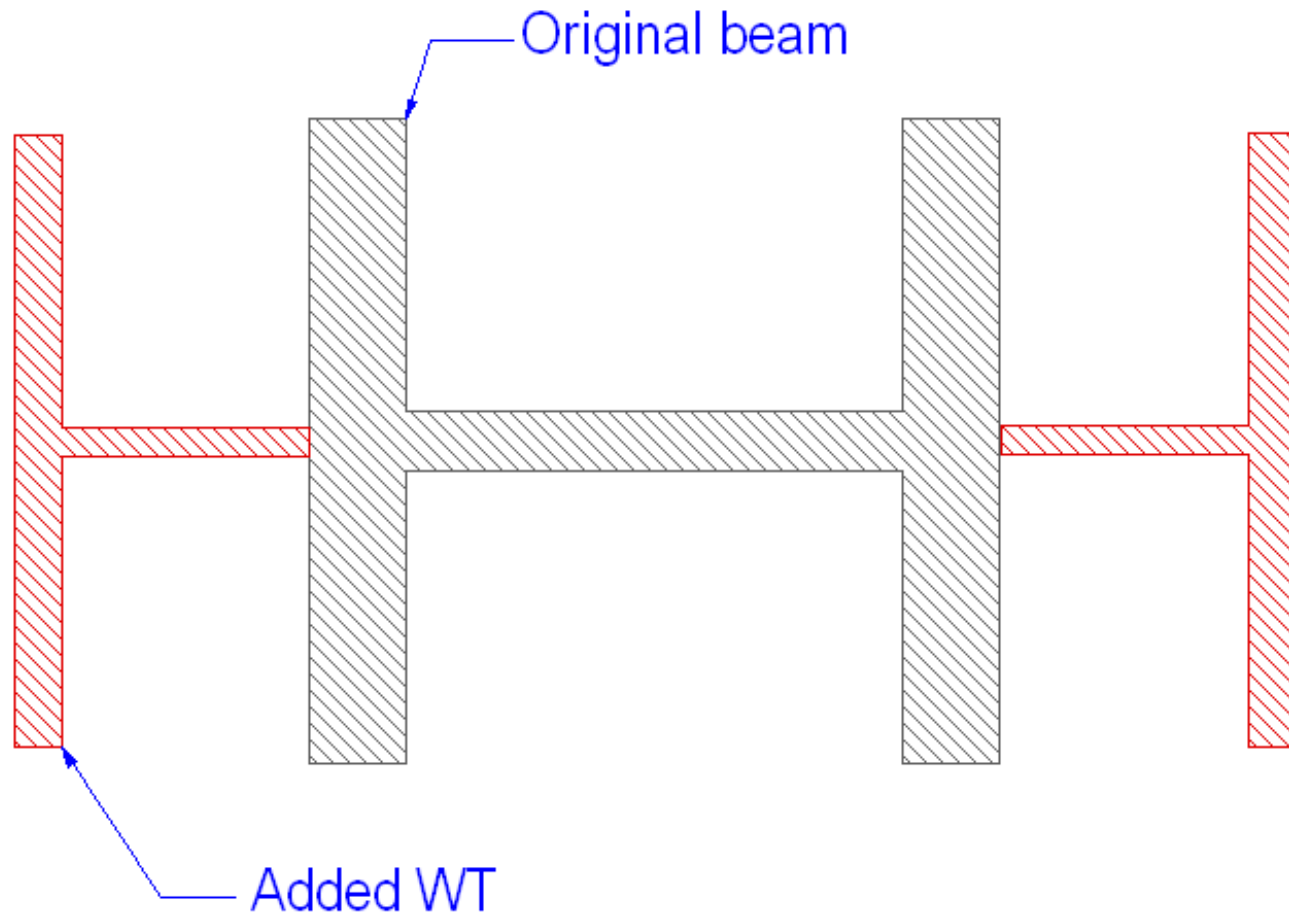
Arm beam cross-section

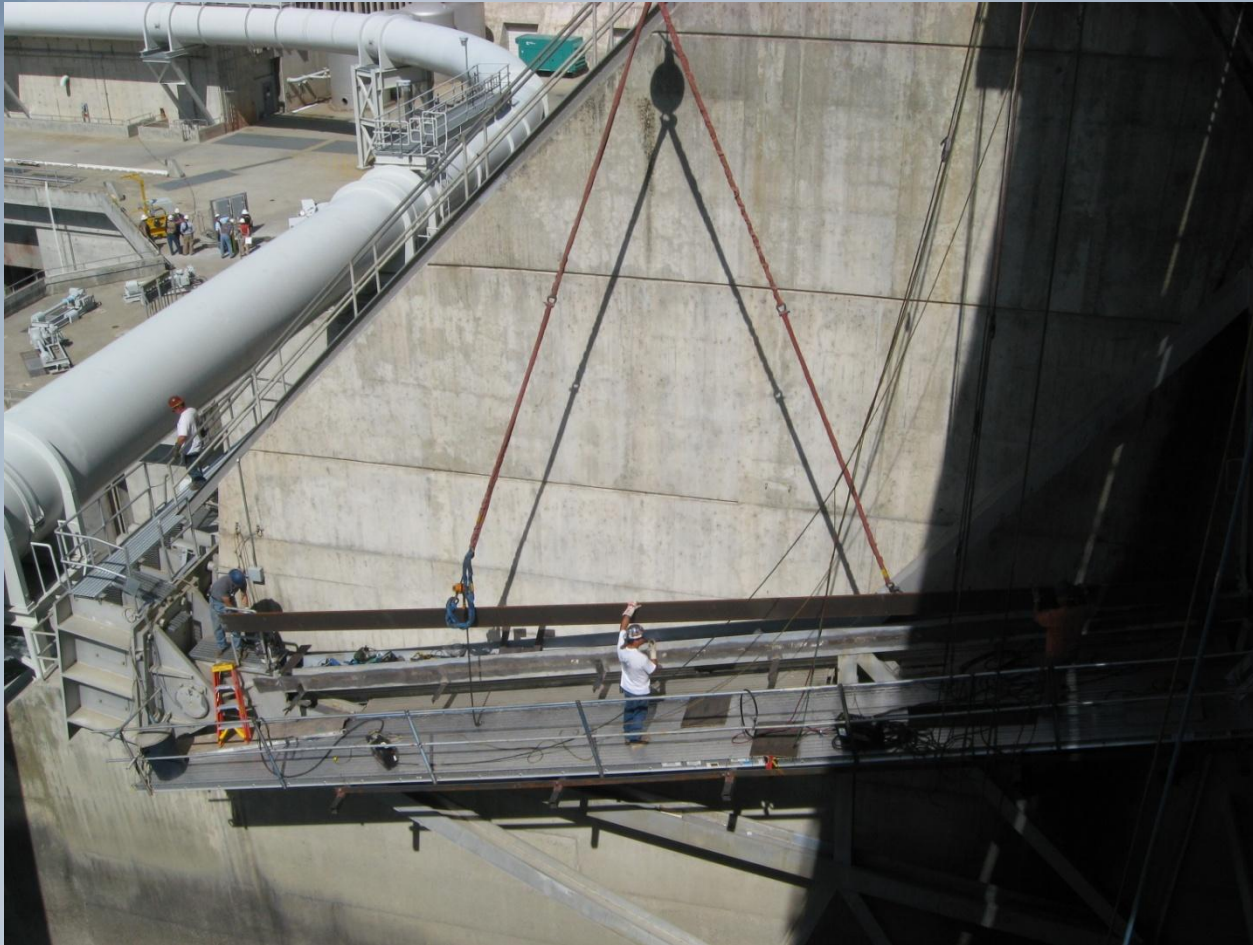
WT being placed

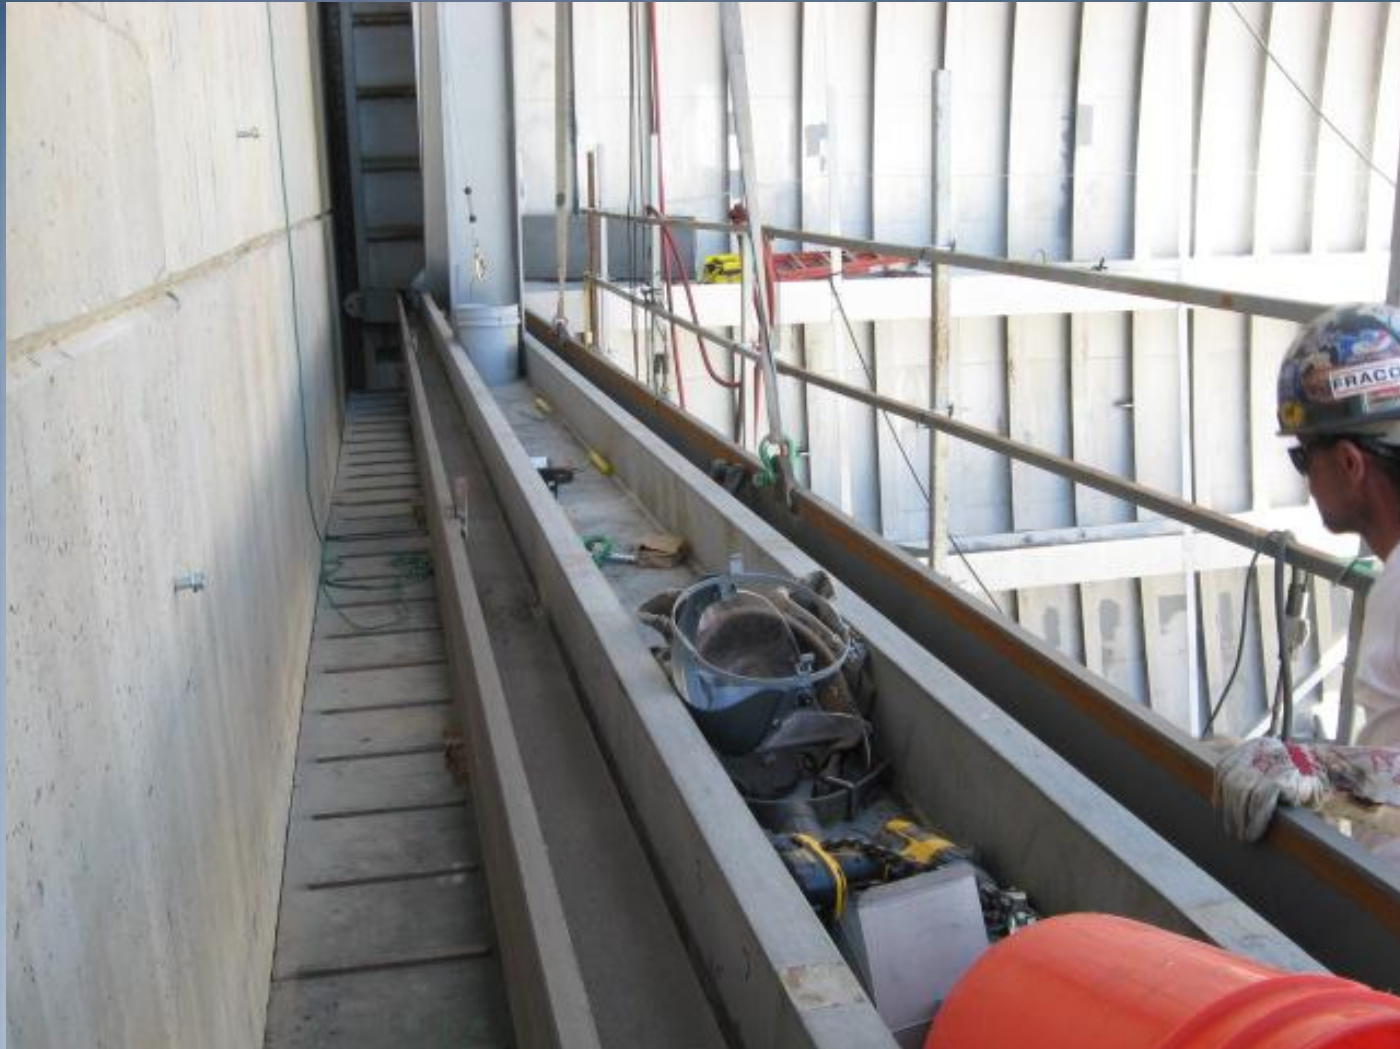
WTs fitted to arm beam

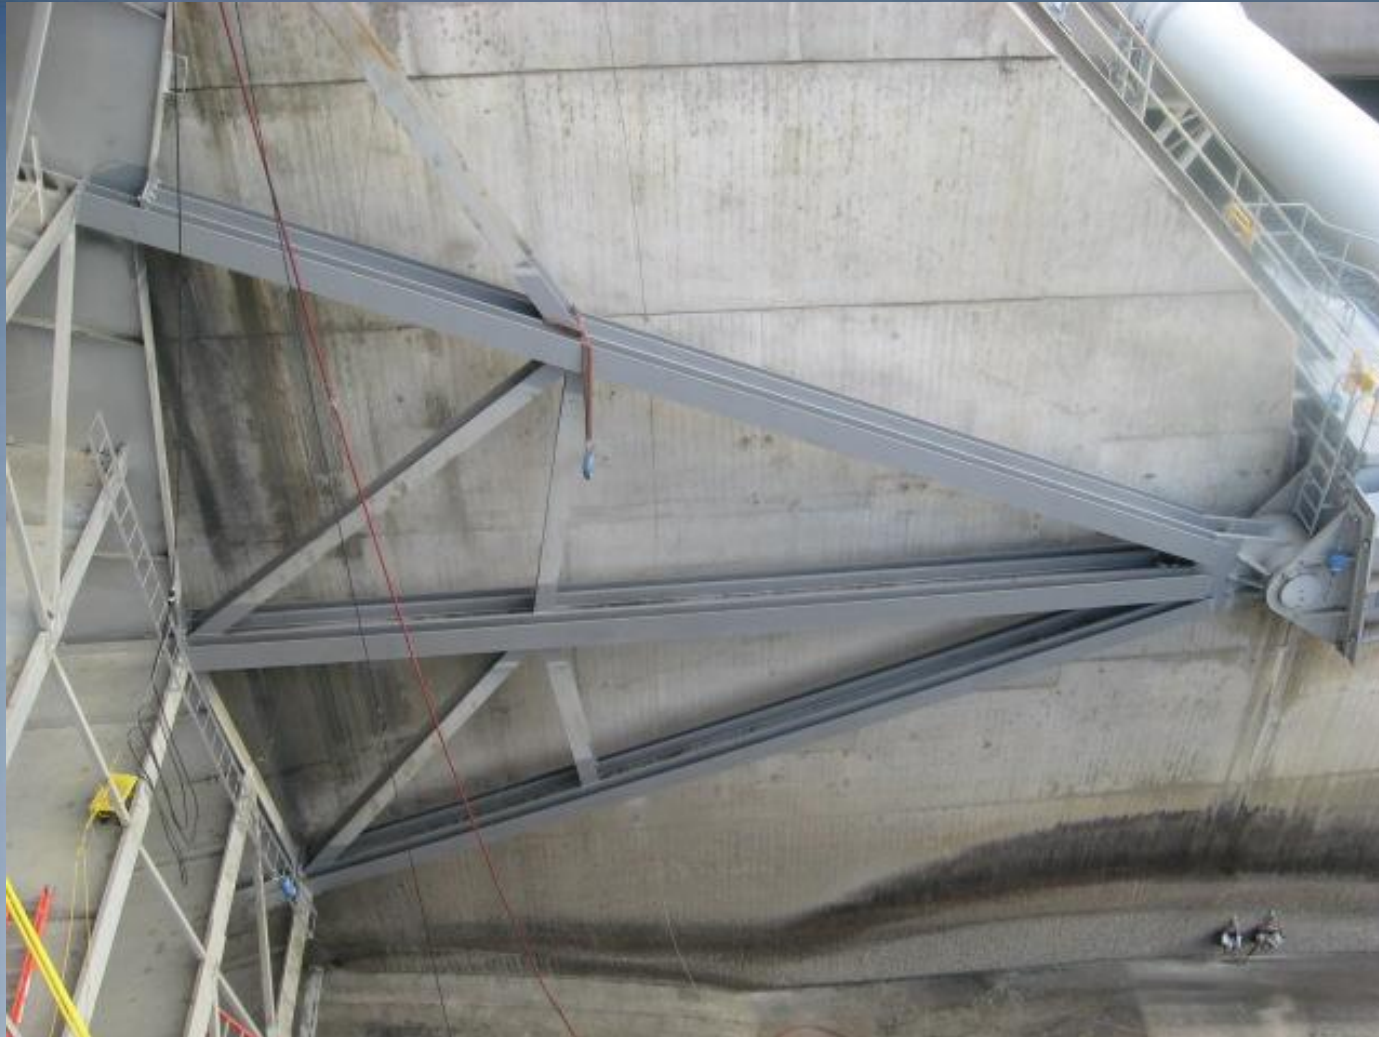
Arm with added WTs

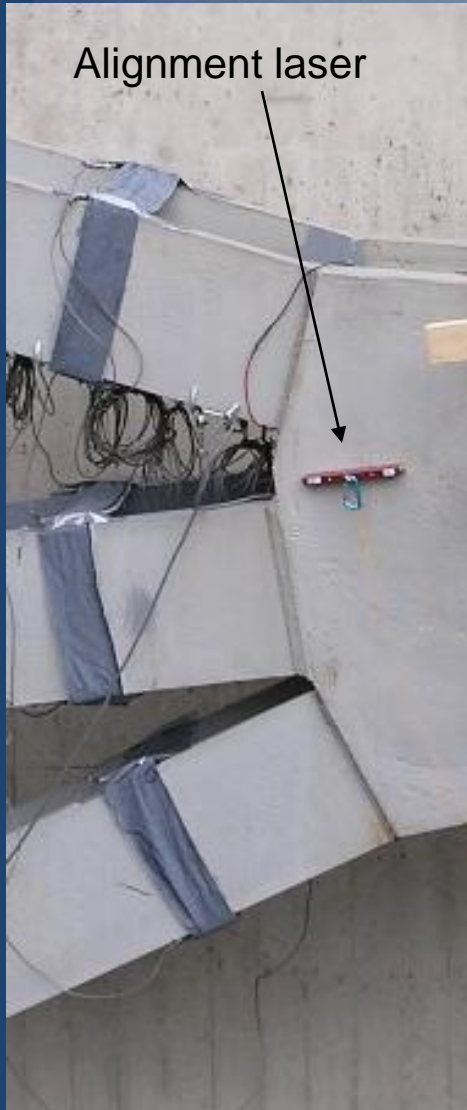
Bearing monitoring system

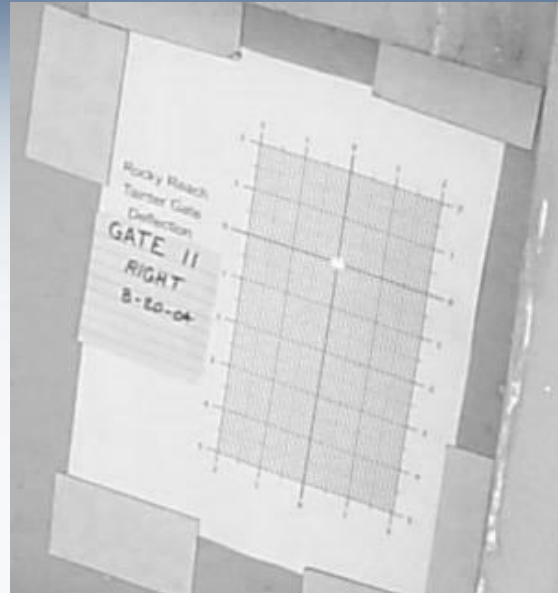
Alignment laser

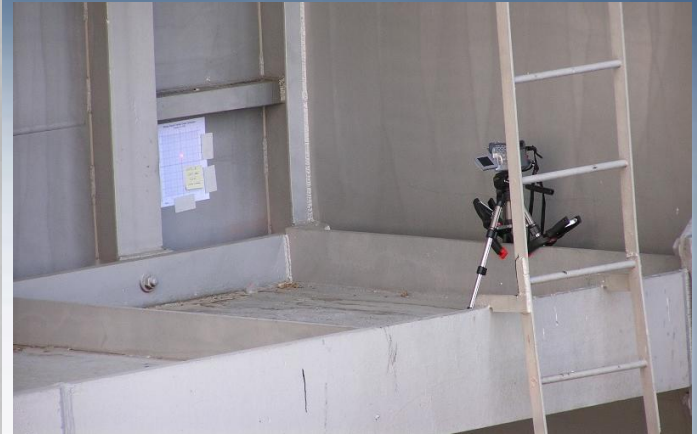
Target grid is installed on the gate skin plate with magnets.

Target and video camera set-up.

Laser mounted on trunnion casting.
